# Archaeological Investigations at the Navarro Street Parking Garage, San Antonio, Texas

# **ARCHAEOLOGICAL INVESTIGATIONS AT THE NAVARRO STREET PARKING GARAGE, SAN ANTONIO, TEXAS**

**Center for Archaeological Research  
The University of Texas at San Antonio  
Archaeological Survey Report, No. 174**

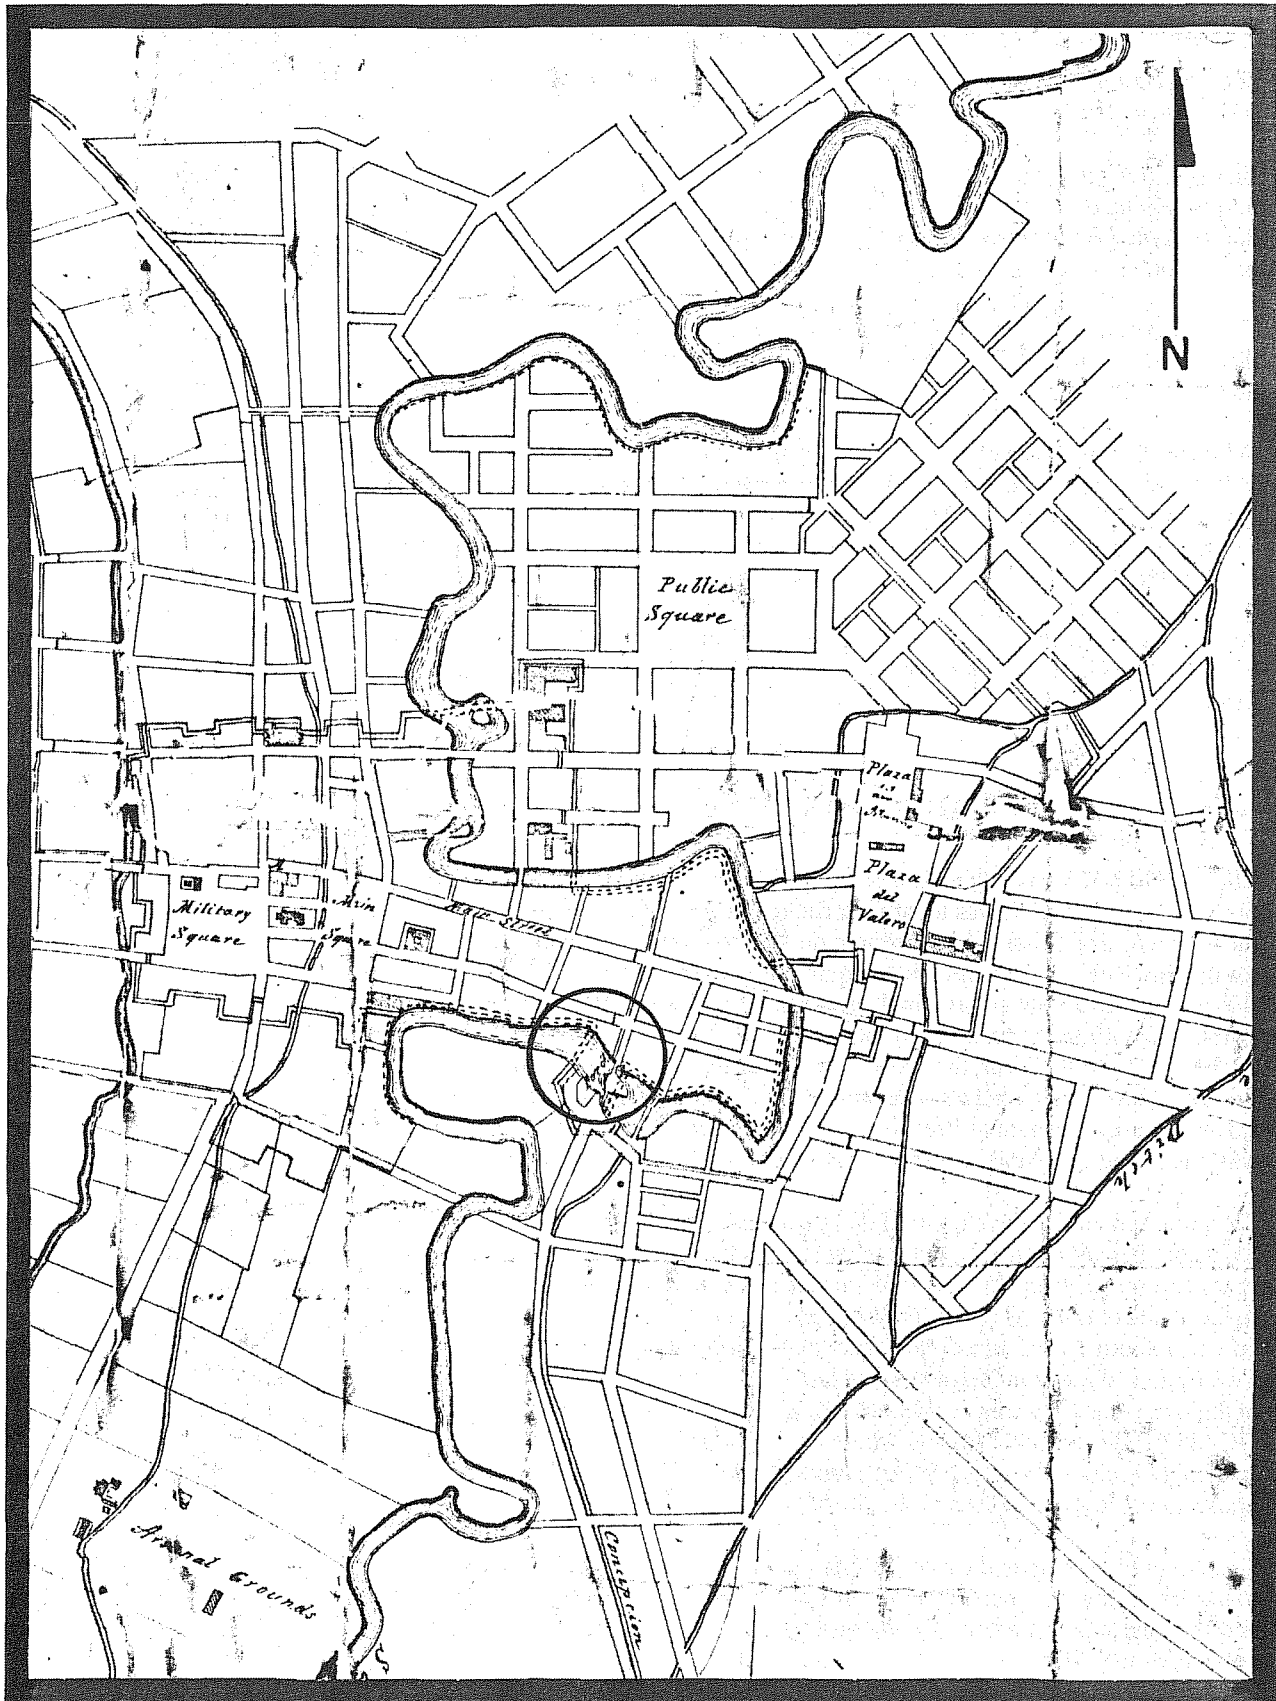
Figure 2. Civil War Map of San Antonio Showing Location of Dam and Acequia. Area of the dam and acequia is indicated by circle.

Subsequent flooding on the river resulted in public pressure to remove the Concepción dam in 1869 as an obstruction to river flow (Corner 1890:43). The city council approved its removal in March 1870 (*CCM*:March 23, 1870), and the next month ordered the open ditch to be refilled (*CCM*:April 11, 1870). By 1873, all traces of the ditch north of South Alamo Street had been obliterated (Figs. 2, 3).

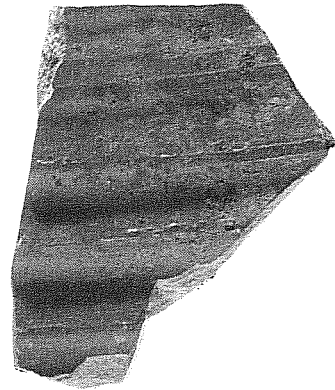
Figure 7. *Artifacts Recovered.*

- a, porcelain painted overglaze;
- b, religious medal, Virgin of Guadalupe;
- c, porcelain, gold painted overglaze;
- d, earthenware *chocolatera* with lead glaze;
- e, white earthenware with red transfer design;
- f, white earthenware with blue shell edge design;
- g, hand-blown wine bottle base;
- h, stoneware with Leon slip from Meyer pottery.

A very small sherd of blue hand-painted ware was found near the south end of Trench A near the bottom of the trench. A blue edgeware sherd (Fig. 7,f) came from among the limestone rubble below the level of the brick rubble in the east end of Trench C. Two red transfer-printed sherds (Fig. 7,e) were found among the disturbed deposits of the west end of Trench C. A rim sherd from an undecorated white earthenware bowl also came from these Trench C deposits.

Stoneware from the site includes a sherd from a jar glazed on the outside with a salt glaze and on the inside with a Leon slip used by the Meyer pottery in Atascosa, Texas (Fig. 7,h). This would probably have been made sometime between 1887 and 1895 (Greer and Black 1971:1-5). Another stoneware sherd from a vessel of similar diameter is somewhat later, having a Bristol glaze on the outside and an Albany slip on the inside. The third piece of stoneware is from a heavy, creamy white bowl-shaped vessel with a rounded rim. All of these sherds came from the Trench C deposits.

Glass fragments recovered during the excavations range from sherds of a 19th-century pale green, hand-blown wine bottle (Fig. 7,g) to 20th-century bright green soft drink bottles. The former came from the same location as the blue edgeware sherd, while the latter were found in the demolition rubble of the brick building and at the deeper levels at the west end of Trench C. A whole olive oil bottle (Wilson 1981:90) also came from the west end of Trench C, as did milk bottle and brown beer, whiskey, and bitters bottle fragments. Tiny pieces of red and blue glass and two pieces of an aqua glass insulator came from Trench A.
